**SUBJECT: Report of Asbestos Abatement Activities
Hawthorne Bowling Alley
Hawthorne, Nevada**

Asbestos Abatement
Hawthorne Bowling Alley
Hawthorne, Nevada

Regarding: Final Report for Non-Friable Asbestos Abatement Project Monitoring, Inspections, Air Clearances & Visual Clearances Performed for Mineral County to Accommodate Demolition of the Hawthorne Bowling Alley; Additionally Provided are Guidelines, Recommendations and Regulatory Requirements for Demolition of the Structure Following the Abatement.

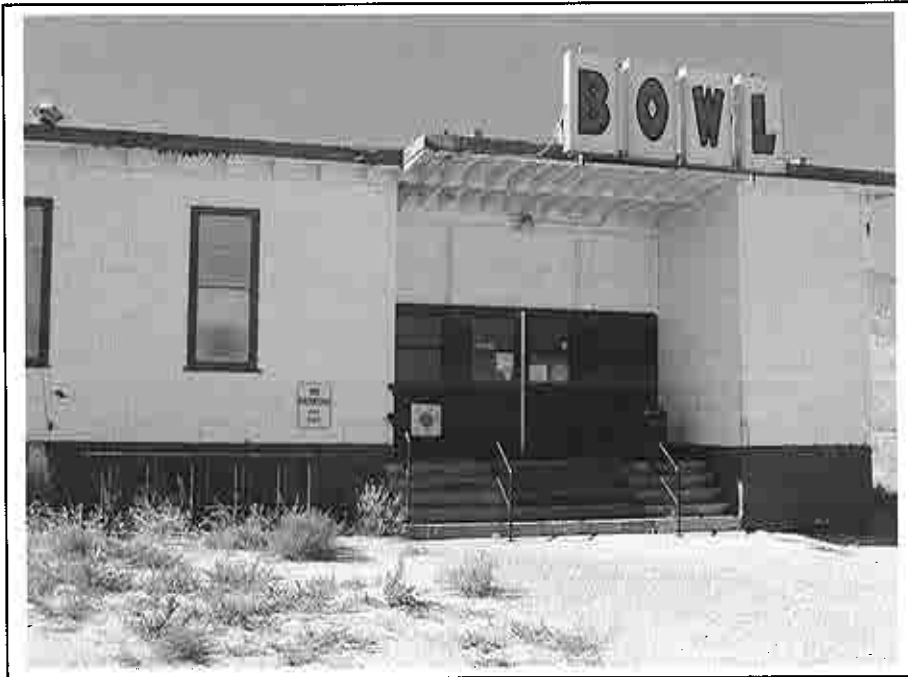
Photo 1:
Front entrance to
bowling alley.

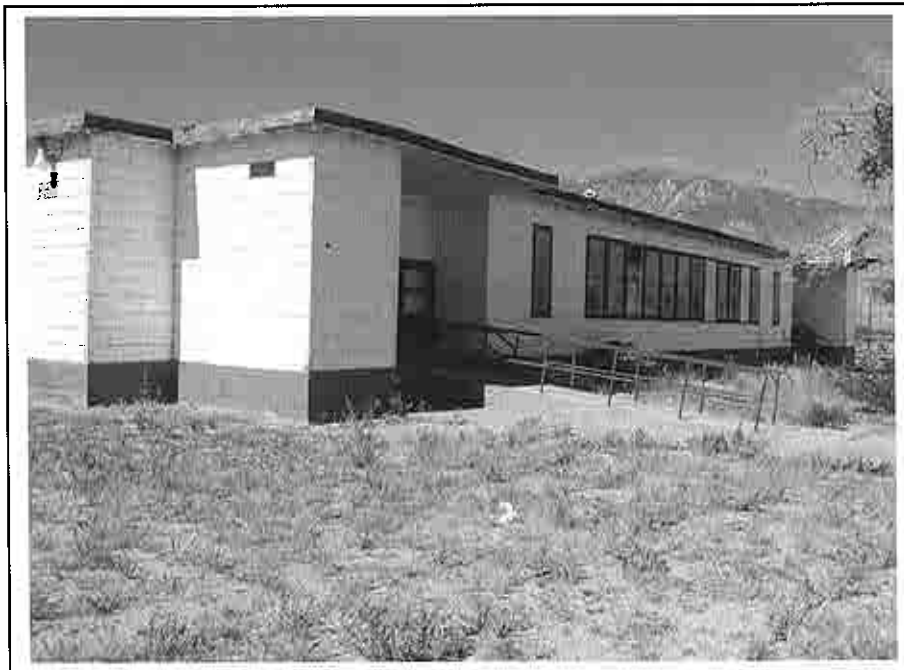
Photo 2:
Facing southwest at
front of bowling alley.
Damaged asbestos
cement tile visible on
upper left portion of
building.

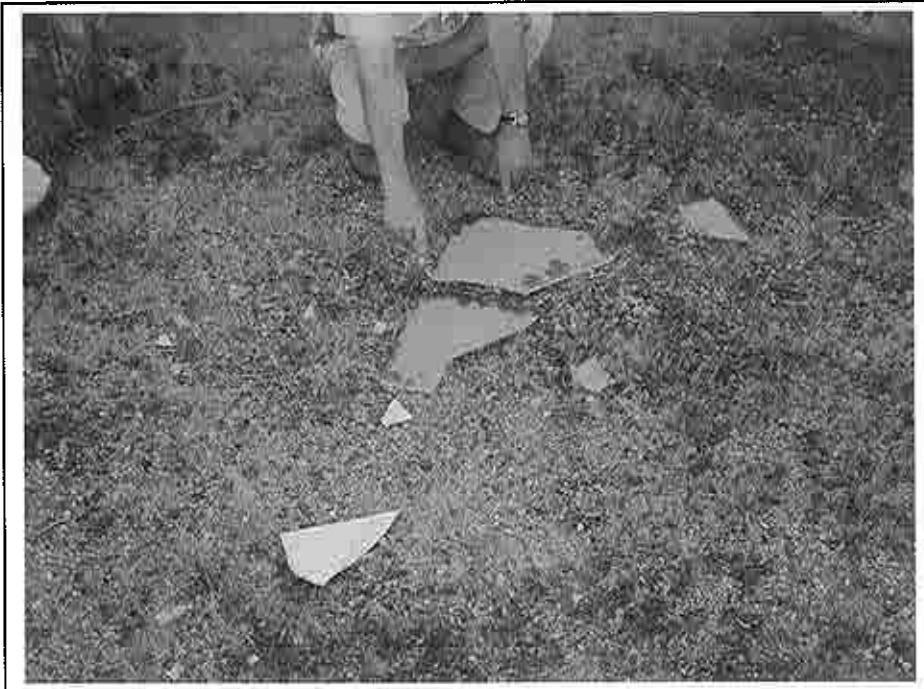
Photo 3:
Broken asbestos
cement tiles on ground
at bowling alley exterior.

Past demolition activities left AC Shingle debris on the ground where there were houses or structures adjacent to and surrounding the Bowling Alley. The demolition of structures in the past without removing the AC Shingles created a condition of soil contamination with visible pieces of AC shingles that range from 1/8th of a square inch to several square inches in size. Past heavy equipment usage for the previous demolition work processed the soil in the area surrounding the Bowling Alley to a condition that there is an unquantifiable potential of AC debris contamination beneath the surface of the soil. Sato Environmental made several rounds of visual inspections in an effort to reduce the possibility of surface soil contamination with AC debris. Without excavating the soil and potentially removing hundreds of cubic yards for disposal as ACM waste, there is no way to assure that no sub-surface contamination exists at the Bowling Alley site. Based on the fact that there is surface soil contamination with AC debris for numerous acres surrounding the Bowling Alley and the fact that Mineral County does not have funds to devote to cleaning up the entire area, it is not feasible to perform sub-surface excavation due to the potential of AC debris contamination being present underground.

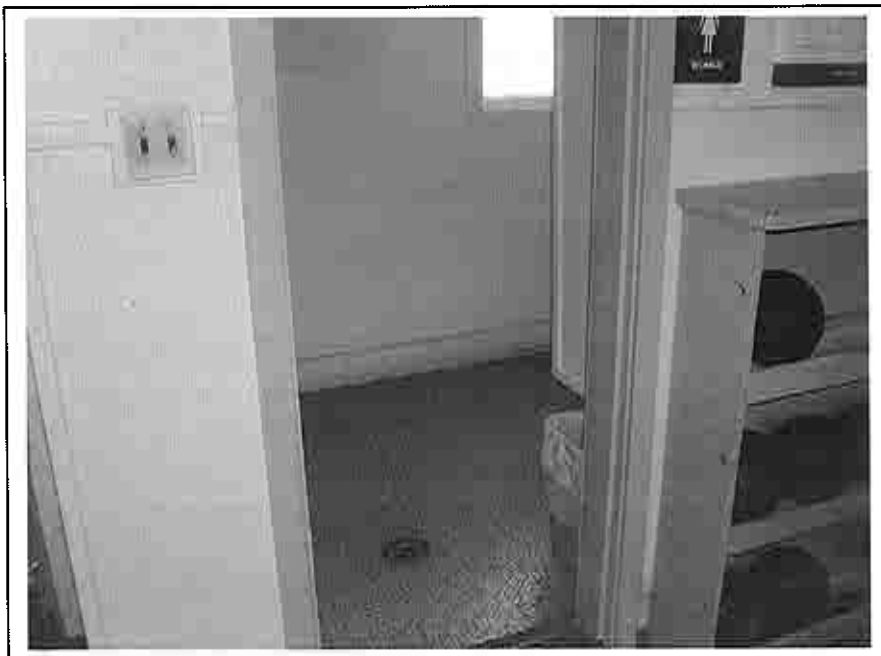
Photo 4:
Asbestos containing
floor tile in bowling alley
bathroom.

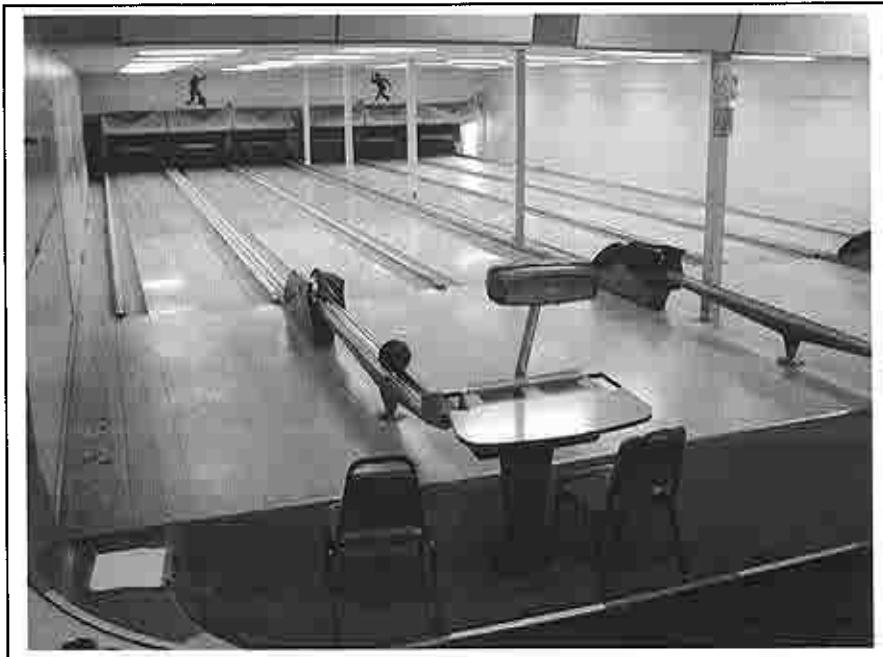
Photo 5:
Bowling alley interior,
asbestos containing
wall panels on portions
of side walls.

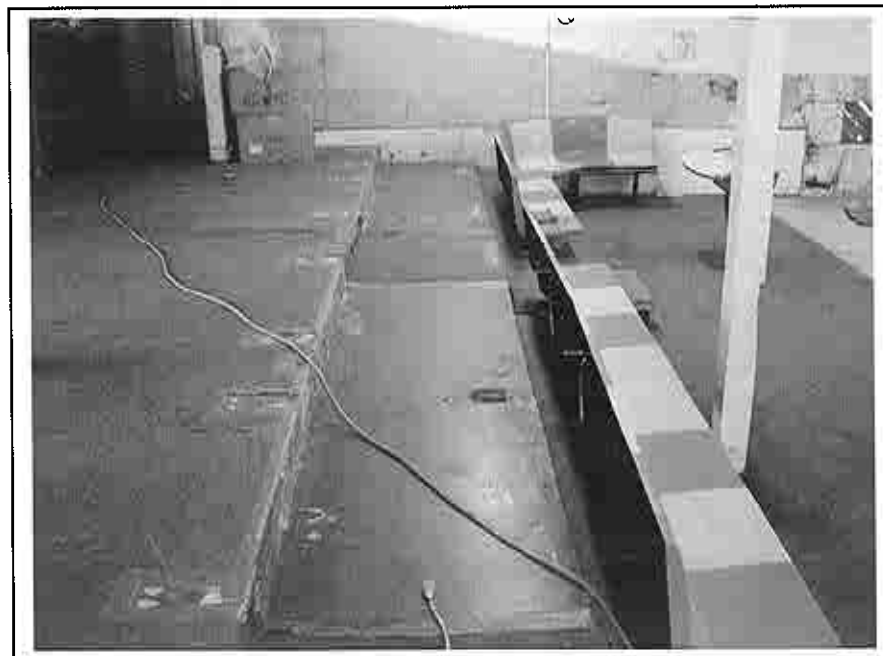
Photo 6: Areas of
abated flooring and wall
panels (brown areas on
background wall).

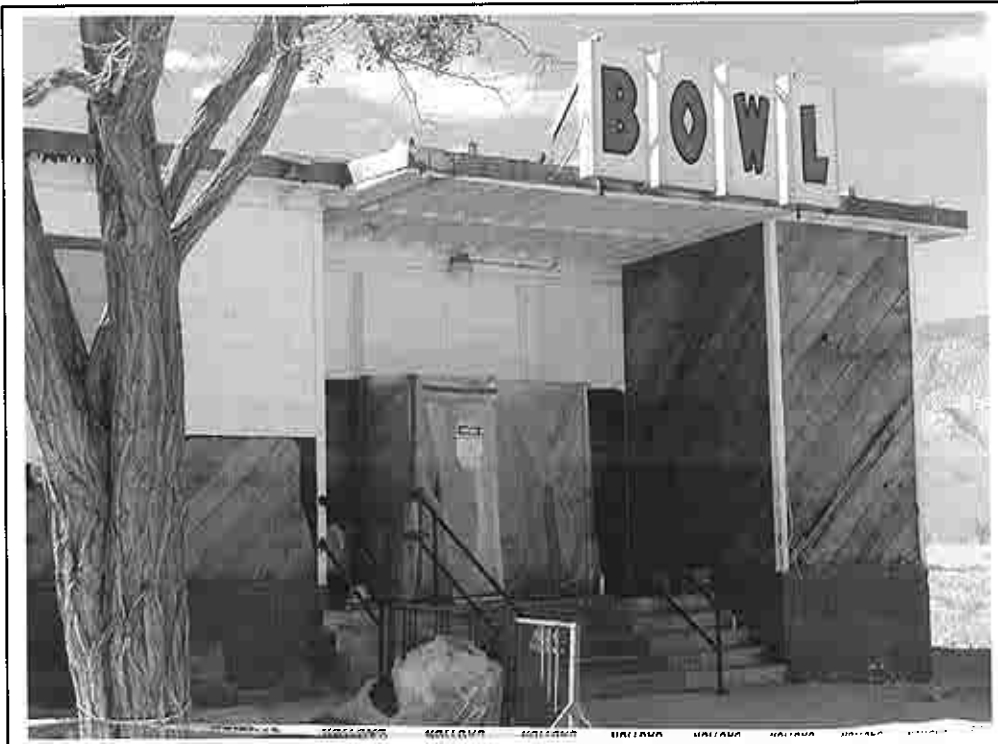
Photo7:
Containment at
bowling alley
entrance.

The Abatement Contractor was required to demarcate the interior work areas with Asbestos Hazard signs and exterior work areas with Asbestos Hazard Warning barrier tape for the duration of the abatement. The workers placed 6-mil polyethylene drop sheets on the floor or ground to 10 feet out from the wall below AC wall materials in work areas to control the debris and wastewater runoff. Prior to AC shingle abatement the Abatement personnel donned respirators and disposable suits to pick up and bag all suspect debris to approximately 50 feet away from the building. To maintain the non-friable condition of the ACM, the shingles and panels were removed as intact as possible and wetted prior to, and during the abatement process. All ACM waste was bagged or packaged immediately and not allowed to accumulate on the ground sheeting. Included in the AC exterior shingle abatement is the removal of all tar-felt paper behind the shingles being removed. Additionally, all nails used to attach the AC panels and shingles to the building were removed and disposed of as contaminated with ACM. During removal of ACM debris on the ground the Abatement Contractor was required to pick up and bag all visible suspect and known ACM debris from the ground perimeter of the building to approximately 50 feet from the building, or to the property line (which ever boundary is nearest to the structure). This debris was to be bagged for disposal as asbestos containing waste.

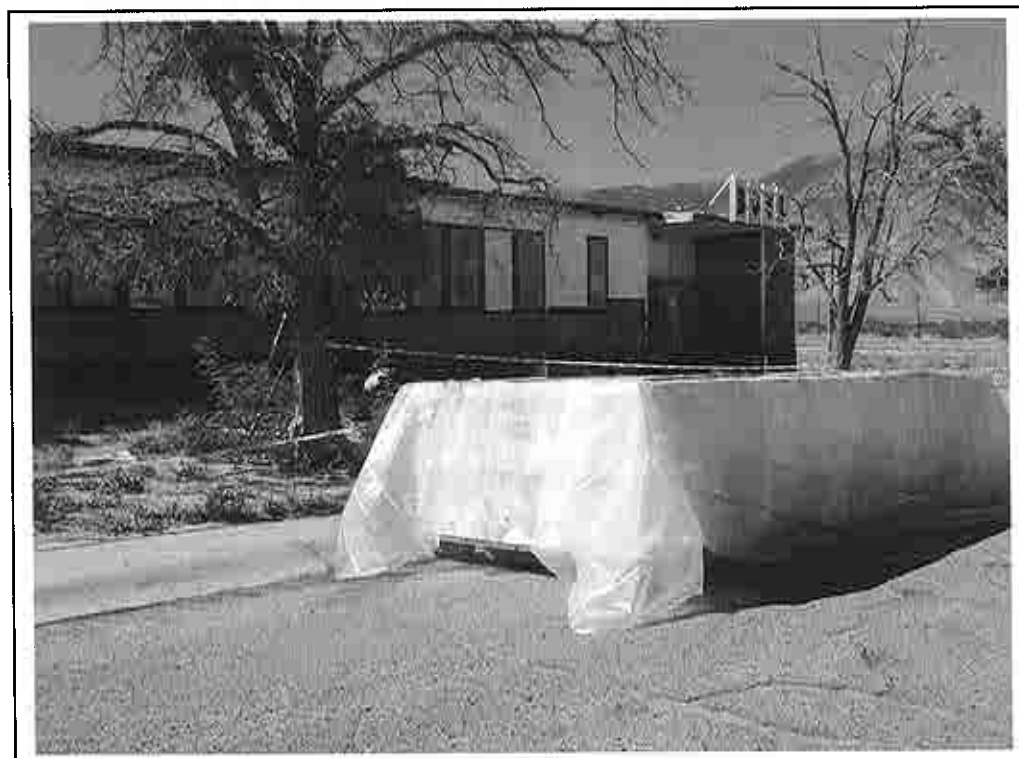
Photo 8:
Visqueen lined
roll-off bin for
waste disposal.

- 6) Line waste hauling containers and/or truck beds with layers of six mil. polyethylene sheeting to assure that they are leak tight during transport of non-friable ACM waste to the landfill.
- 7) Area and/or Personnel exposure air monitoring could be required by OSHA during the demolition of Non-Friable ACM.
- 8) Non-Friable ACM waste allowed to be left during demolition of a structure is commonly disposed of as construction debris at landfill sites.
